# New Holstein School District Facility Audit

February  
2019

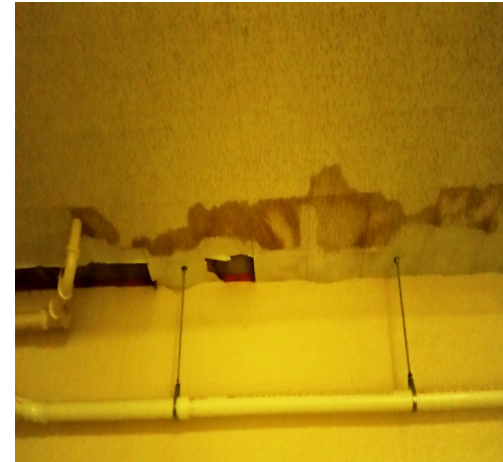
Open wall and ceiling penetrations

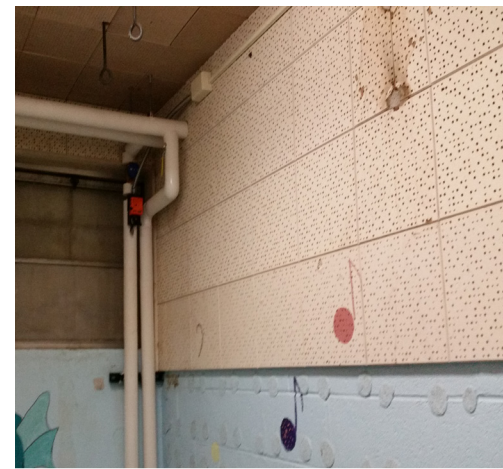
Stained ceiling and wall tiles

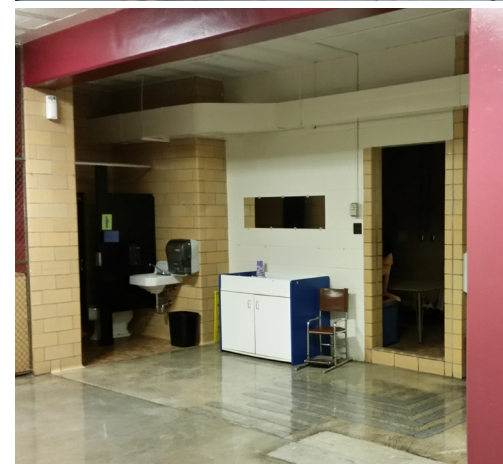
Existing locker room area

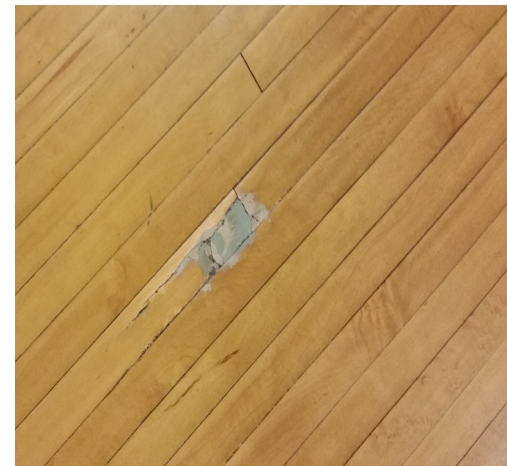
*Damaged wood gym floor*

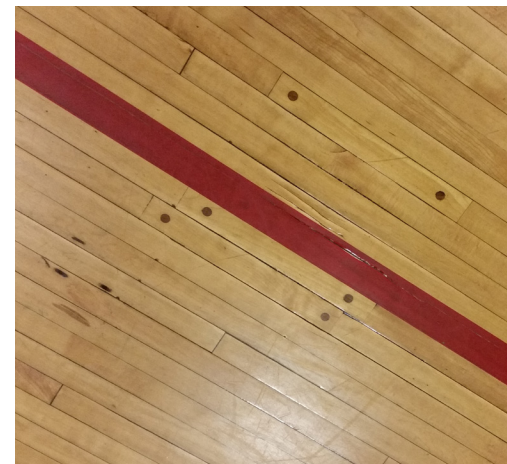
*Damaged wood gym floor*

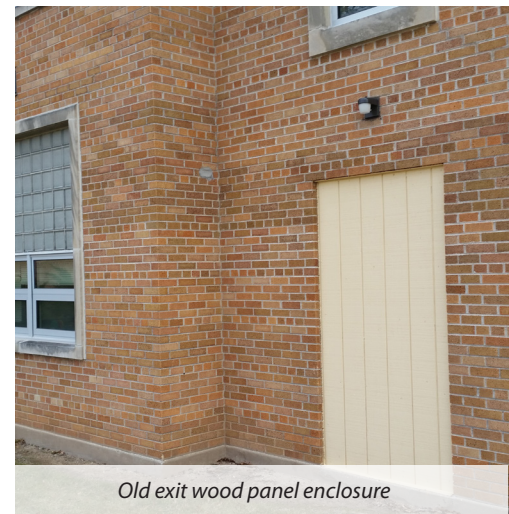
*Old exit wood panel enclosure*

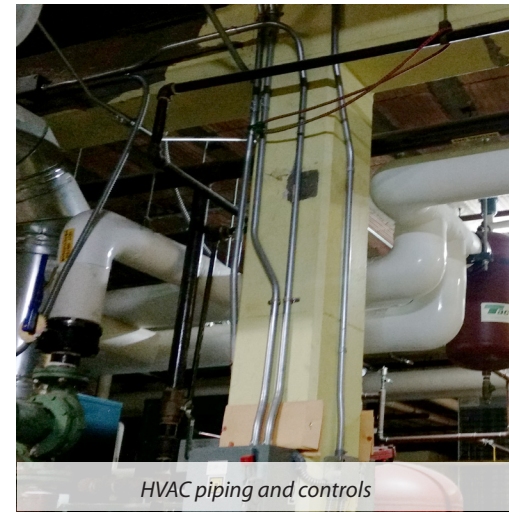
*HVAC piping and controls*

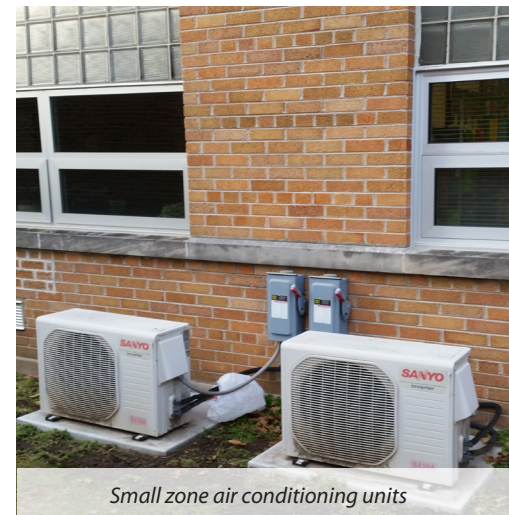
*Small zone air conditioning units*

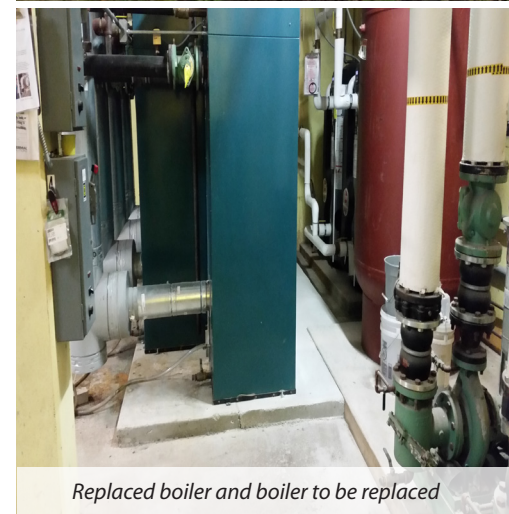
The heating boilers have been maintained with scheduled replacement and some of the boilers are currently due for replacement. Continuing with the scheduled replacement of boilers and other large mechanical equipment prevents unanticipated and high replacement costs and maintains efficient operation and occupant comfort.

*Replaced boiler and boiler to be replaced*

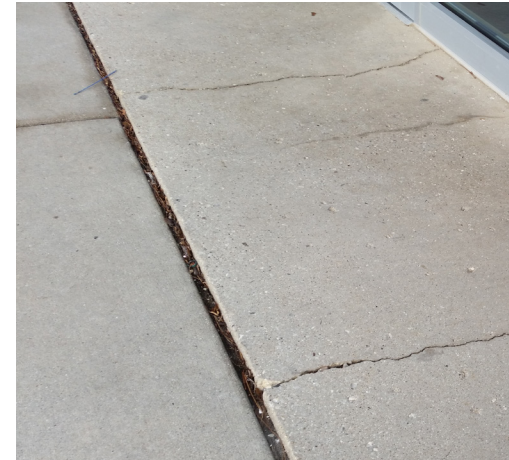
*Exit landing cracks*

Repair and replace all cracked, deteriorated, and missing concrete to prevent slips, trips, and falls; improve evacuation egress; and protect entrance thresholds. Replace food service receiving step with ramped concrete to the flat concrete landings to improve access for frequent and repetitive use by site and delivery staff. Add to other elevated exit landings ramped concrete to prevent slips, trips, and falls; and improve evacuation egress. Add handicapped curb ramp to walk from exit 8 on east side of building to the street leading to the park across the street.

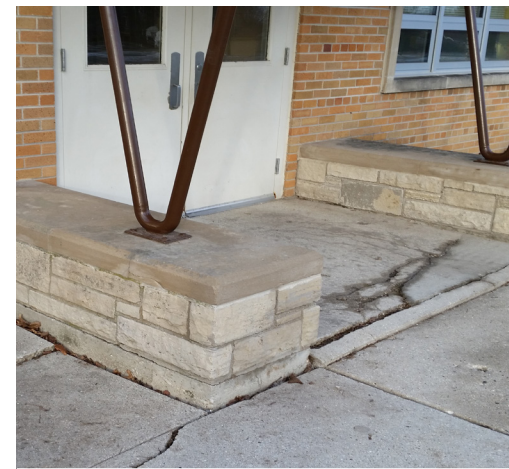
*Exit landing and walk cracks*

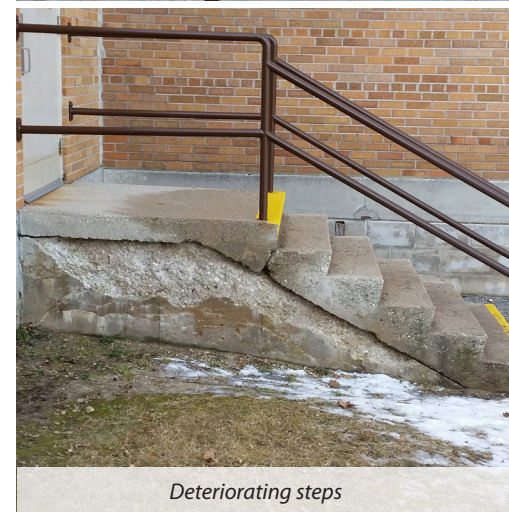
*Deteriorating steps*

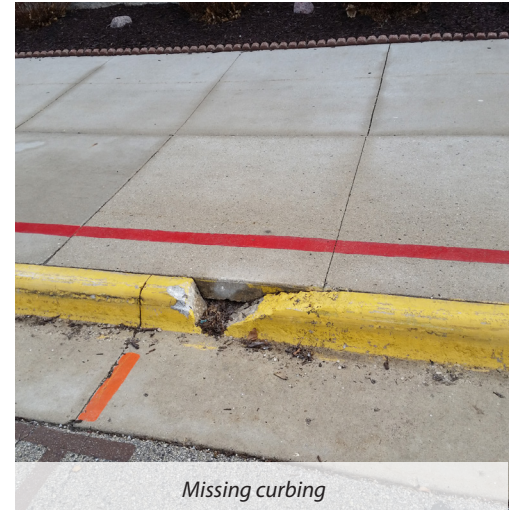
*Missing curbing*

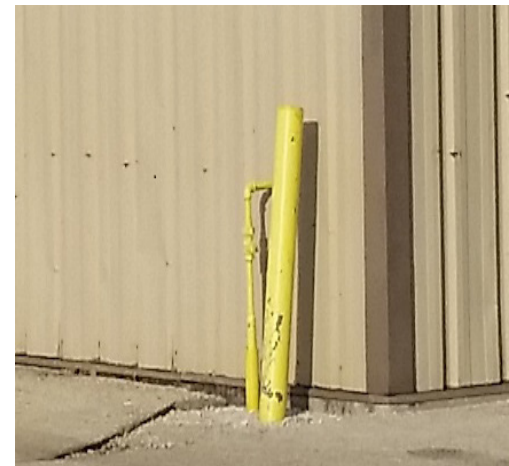
*Cracked bollard base*

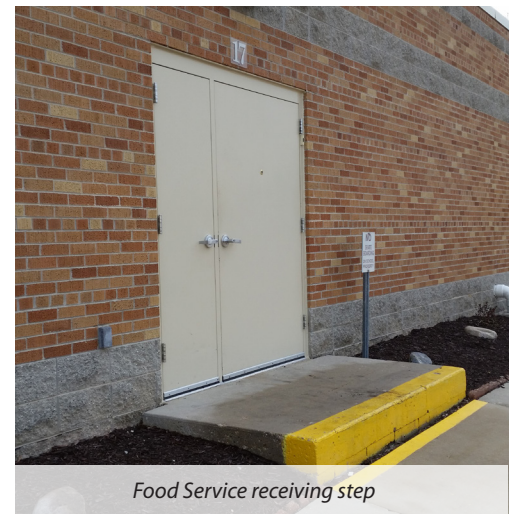
*Food Service receiving step*

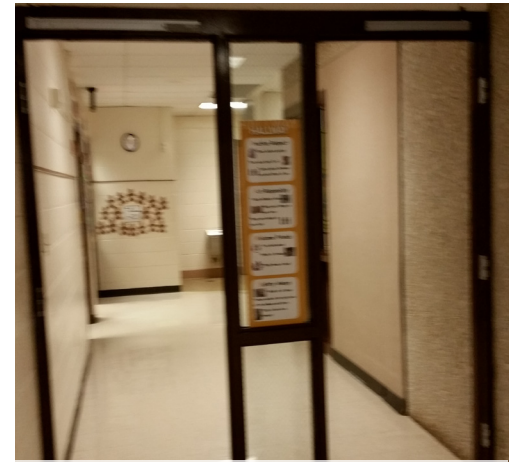
*Missing corridor separation doors*

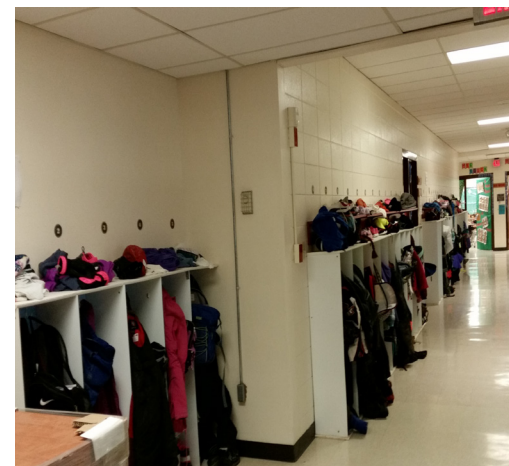
*Storage cubbies in corridors*

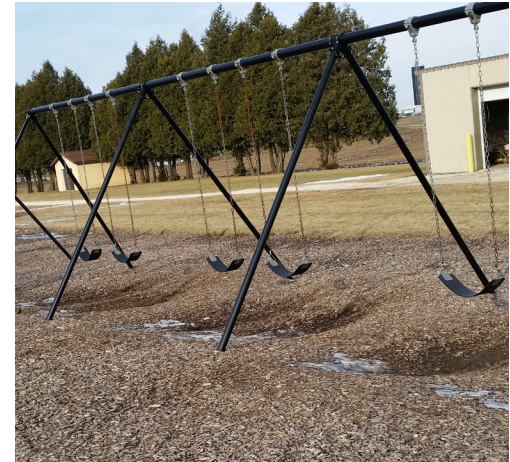
The greatest concern for the landscape is the fall protection surfacing materials. The existing fall protection material is wood chips. There are deep surface material kick out areas and hard compressed areas under the playground equipment.

*Fall surface kick out areas under swings*

Set a standard for the play area fall surface types and conditions. Resurface and maintain the fall protection to the set condition to increase safety.

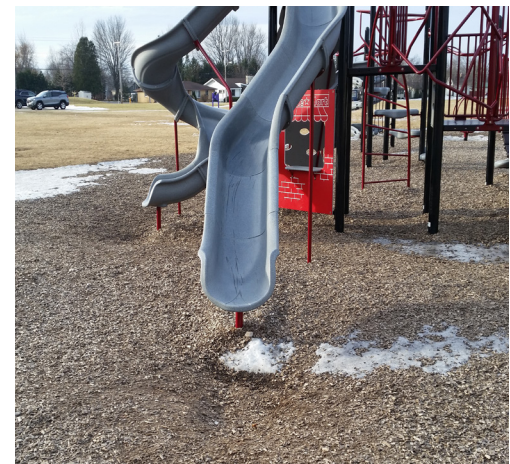
*Compressed fall surface under slide*

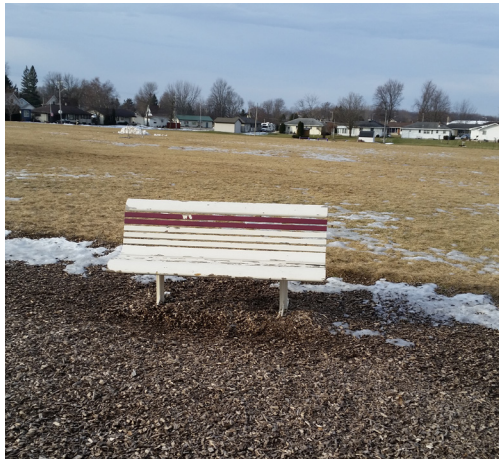
Additionally, there is failing paint on the walking path equipment. The paint has faded and started to wear off. The paint on this equipment also does not match the colors the nearby and newer playground equipment.

*Existing bench with peeling paint*

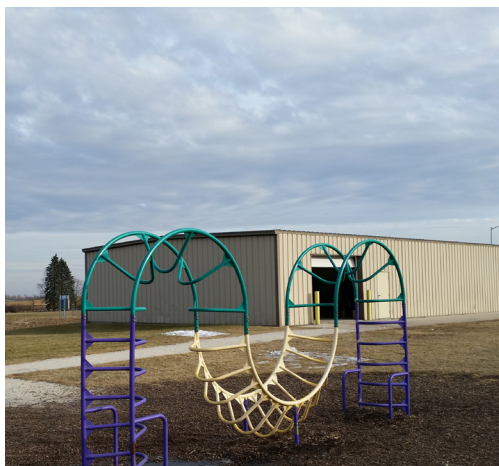
*Walking path equipment with worn paint*

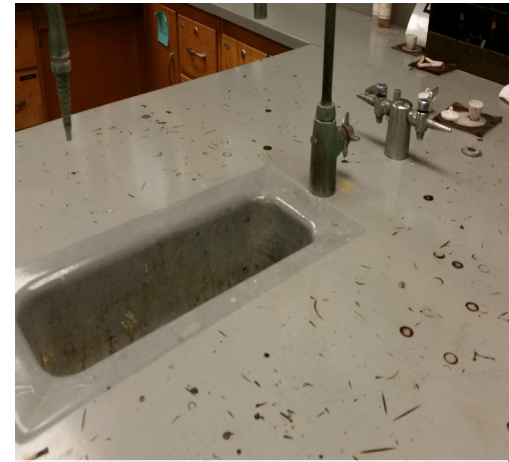
*Damaged work table*

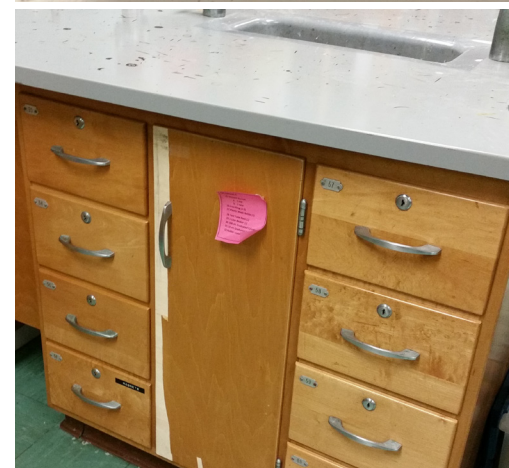
*Chipped cabinets*

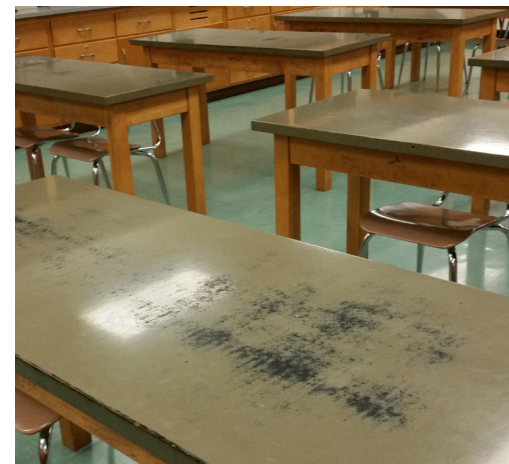
*Worn work table tops*

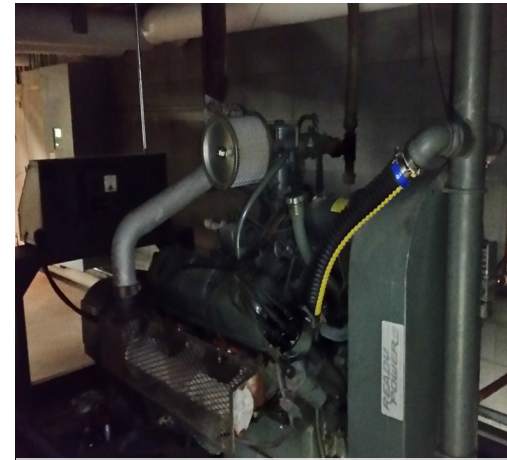
*Old high school generator*

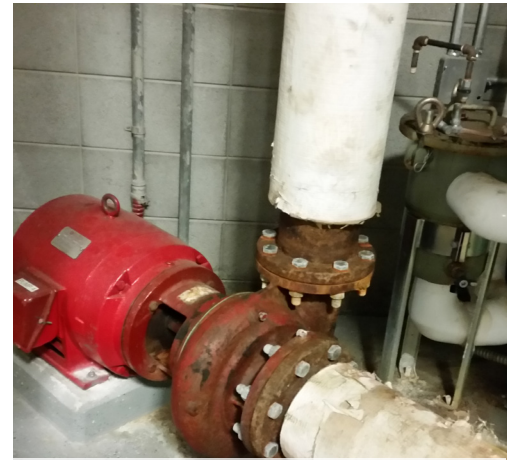
The next building operations concern is the condition the chilled water pumps and lack of recommissioning the other building systems, equipment, and controls. The chilled water distribution system includes inefficient pumps and constant volume chilled water delivery to the terminal HVAC units. The existing pump motors lose energy in the form of heat, friction, and other motor (core) losses. The current pumping system is delivering a constant amount of water throughout the building at a constant water supply temperature. The overdue recommissioning of other pieces of equipment, systems, and controls increases the potential for other inefficient building operations such as the chilled water pumping.

*Constant volume chilled water pump*

Replace the chilled water pumps and motors with NEMA premium efficiency motors. Install variable speed drives on the pump motors to reduce the energy used by slowing down the motor when the demand for chilled water flow is less than the maximum amount. Recommission the other building operations equipment, systems, and controls to schedule, sequence, and operate within the most efficient set points for building operations during varying conditions. At a minimum control strategies such as morning warm-up, maintaining night set-back temperatures and classroom temperature monitoring will be verified or restored with the recommissioning.

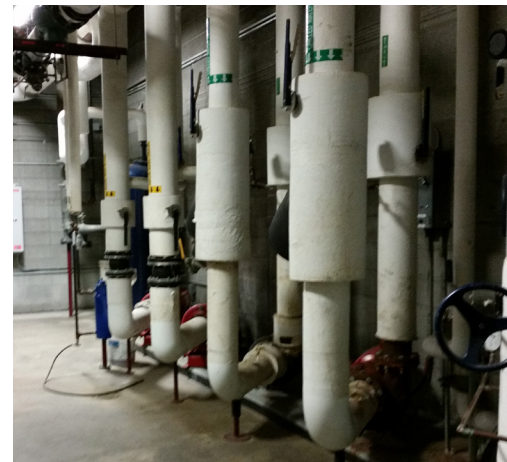
*Variable volume hot water heating pumps*

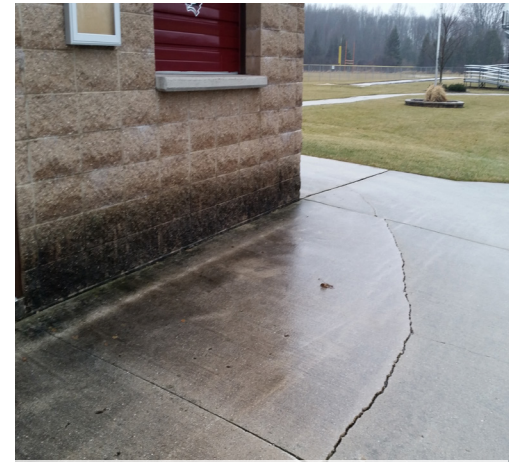
*Existing walking cracks*

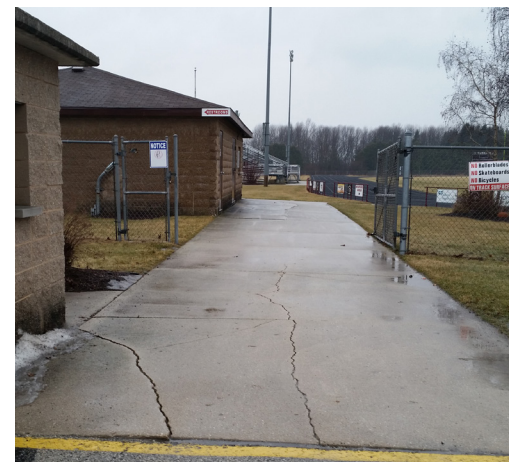
*Existing walkway cracks*

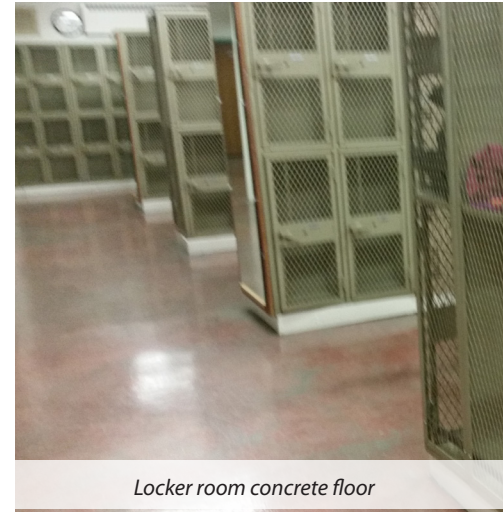
Locker room concrete floor

The concern for locker rooms is the appearance of the interior finishes. The floors are polished concrete with urethane finish. The finish is worn, pitted, and due for re-coating.

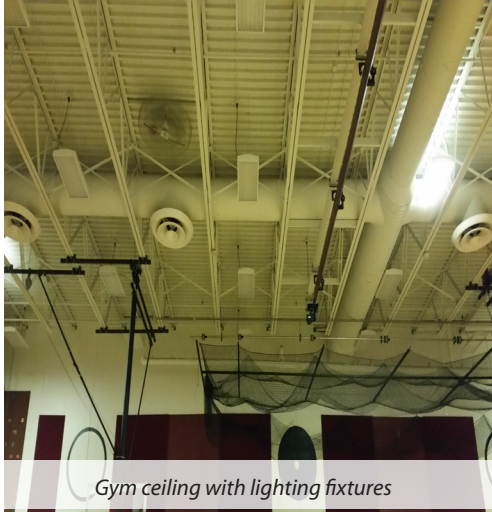
Gym ceiling with lighting fixtures

The middle school gymnasium currently utilizes T8 fluorescent fixtures for lighting. This source of lighting is less efficient due to the watts used compared to the lumens it distributes.

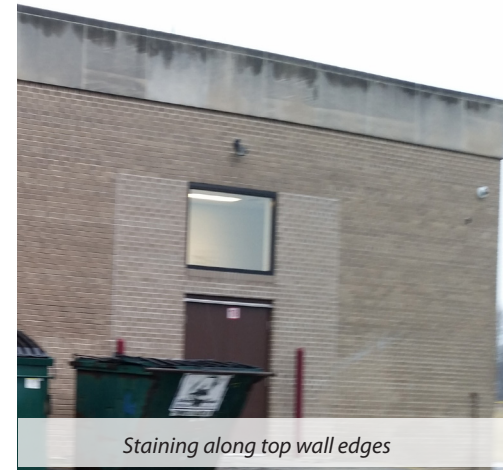
*Staining along top wall edges*
