# New Holstein School District Facility Audit

February  
2019

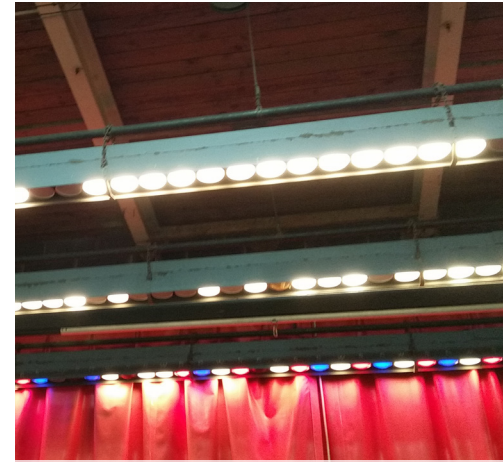
Stage lights and suspension system

Replace the stage lighting fixtures, dimming controls, electrical panels, and hoist mechanism.

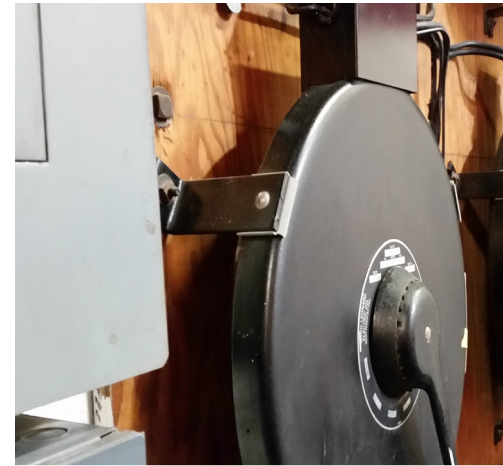
Stage electrical panels and dimmers

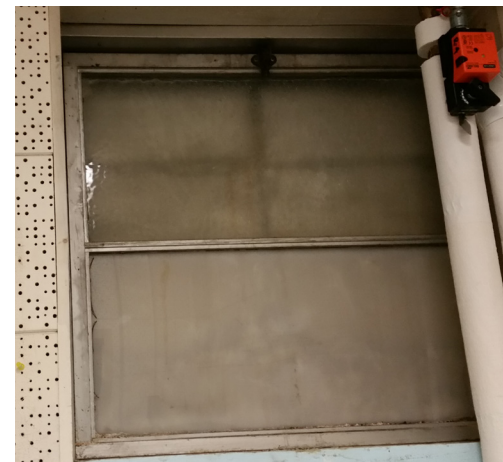
Covered Glass Block Window

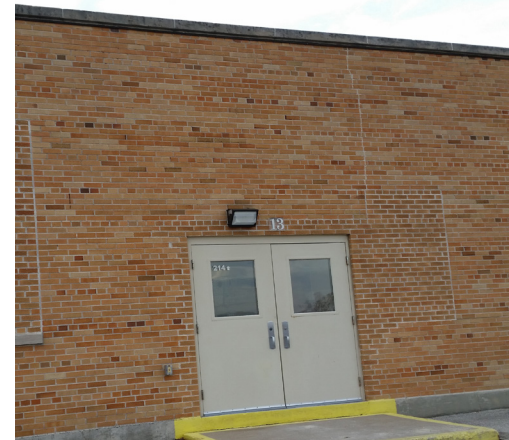
The second greatest concern are the gaps between the hardscapes and building perimeter. Gaps and cracks exist around the edges of the hardscapes at the building perimeter allowing for infiltration along the building foundation and under the hardscape material. This infiltration reduces the useful life of the hardscape surfaces and building foundation. During excessive rain or snow/ice melt periods the infiltration may also lead to interior leaks and flooding.

*Gaps along building perimeter*

Add concrete skirts in place of asphalt around perimeter of building to improve egress and reduce infiltration. Replace asphalt with concrete between gym and 1956 wing on north side of building to improve drainage, increase surface stability, and reduce potential water infiltration. Add concrete pad for generator and air conditioning condensers as deemed necessary. Crack clean and fill, seal coat, and re-paint asphalt to finish disorder created from the above listed concrete.

- Add concrete skirts around perimeter of building.
  - Crack and gap fill between concrete skirts and building perimeter
  - Add concrete to replace asphalt between gym and 1956 wing.
  - Add concrete pad for generator and air condenser units.
  - Repair transitions from concrete to existing asphalt, crack fill, and seal coat asphalt.
  - Paint traffic directional and parking lines.
-

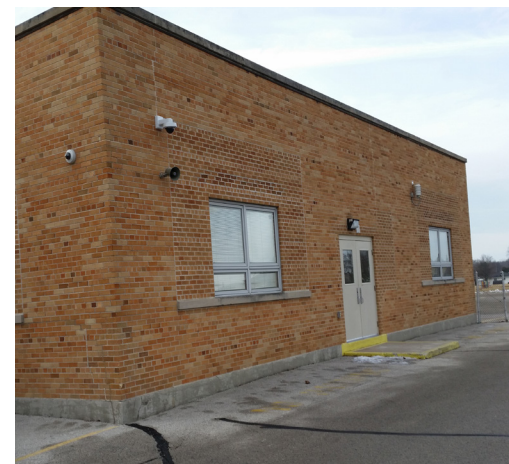
*Gaps around building perimeter*

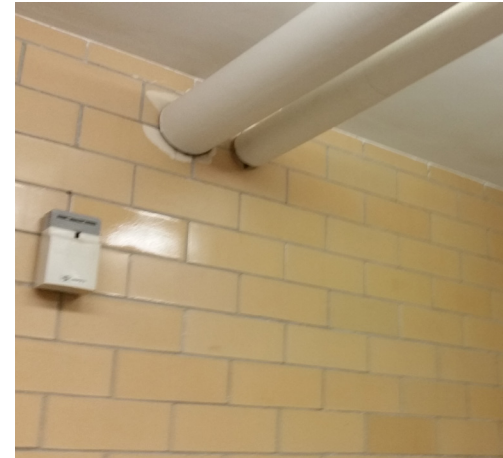
*Exposed pipes and penetrations*

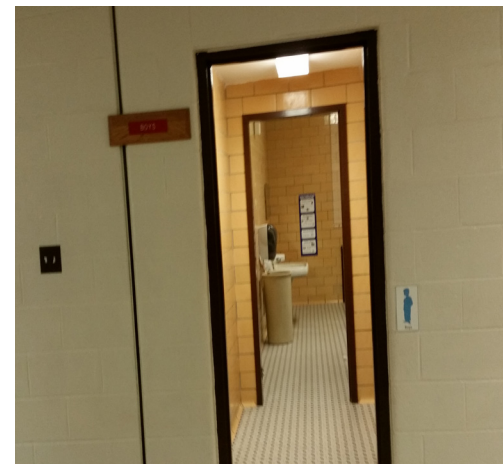
*Narrowed door frame passages*

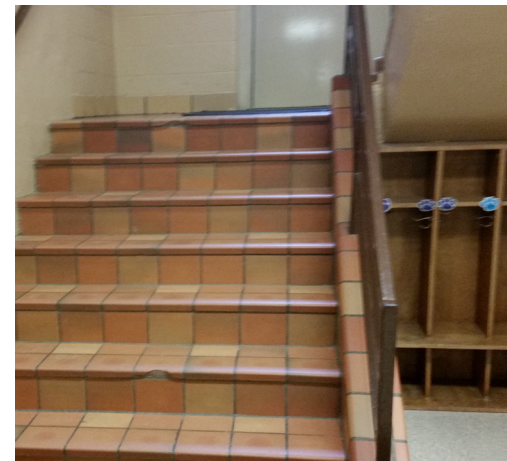
Ceramic tile in stairwells

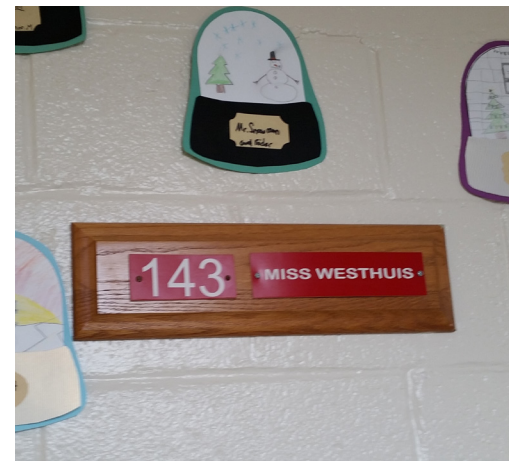
*Room numbering and use signage*

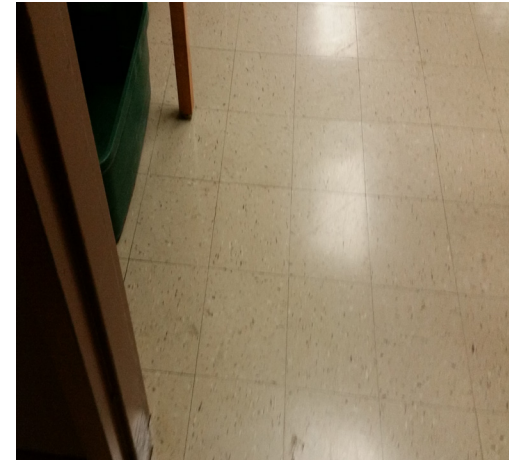
Classroom VAT tile

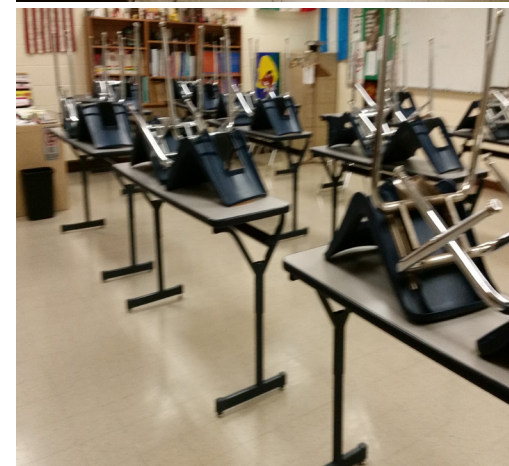
Classroom VAT tile

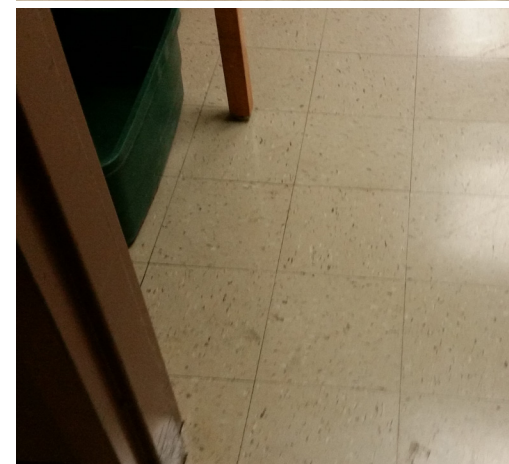
Classroom VAT tile

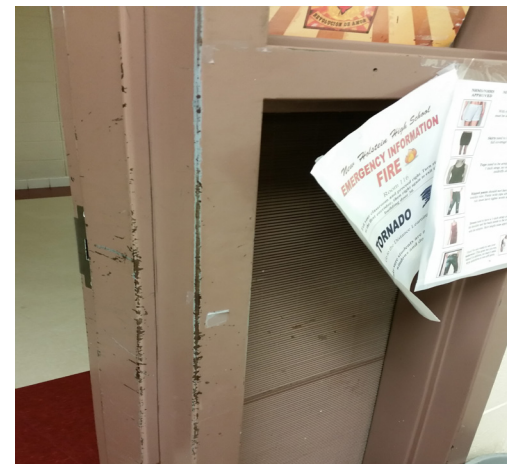
Classroom door frame

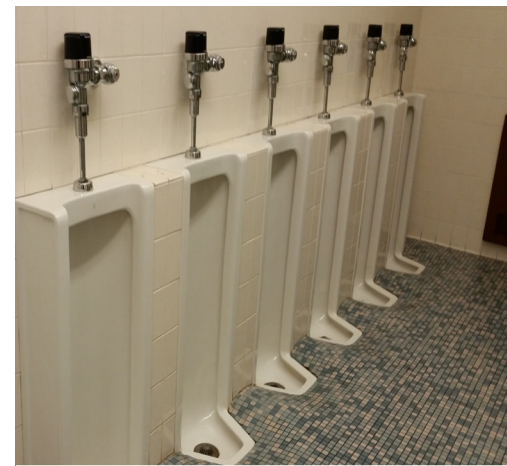
The greatest concern in the restrooms are wall tiles, floor tiles and fixtures are stained and out of date. The restroom stall partition colors and materials clash with the other finishes in the rooms.

High school floor tiles

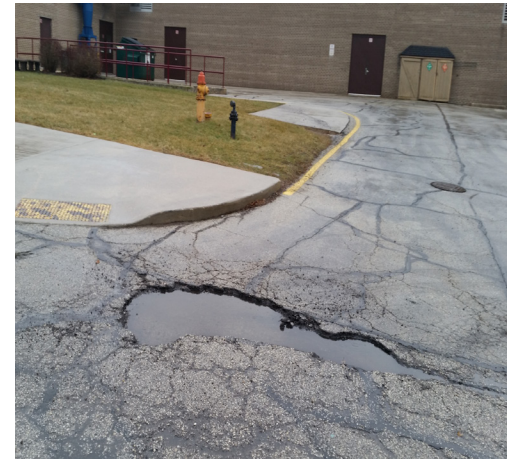
The second greatest concern is the condition of the west lot asphalt. Pot holes, large cracks, and gaps have formed on the asphalt surface. The drainage from the lot is spilling over the west edge and draining to the athletic field areas.

West lot asphalt pot hole

Excavate the west lot base for proper drainage, replace asphalt, and restripe and paint. Excavate the east lot and visitors' lot base for proper drainage, replace asphalt, and re-stripe and paint. Most of this work is planned for completion over the summer in 2019.
