# New Holstein School District Facility Audit

February  
2019

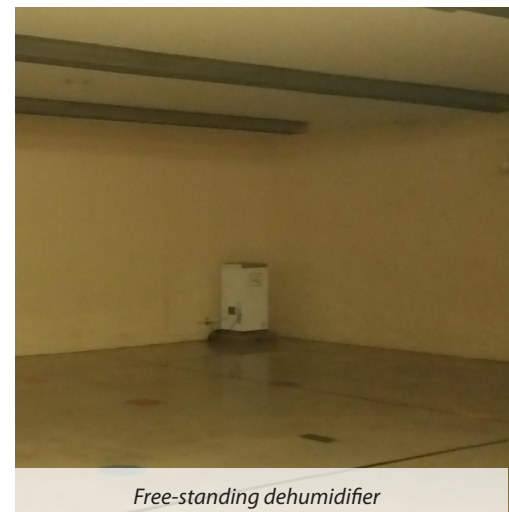
The greatest concern is the lack of space utilization for this large area. The justification for the poor space use appears largely due to the poor facilities conditions of the areas. In the large multi-purpose room the walls and ceilings are not adequately sealed. Throughout the area the ceiling tiles and in the music areas, wall tiles are stained and damaged. In the locker rooms reside occupied offices, unused shower rooms and restrooms, and large changing areas all in poor condition. The floor, walls, and ceiling in the multi-purpose room are worn. A makeshift plywood storage room/ area has been constructed in one corner of the large room limiting the activity space and creating a safety concern. The ventilation is inadequate with extremely humid conditions during the non-heating seasons and unbalanced tempered air throughout the area during the heating season. The lighting and controls are inefficient and due for replacement.

Stained ceiling and wall tiles

Redesign layout of area to improve space utilization. Reduce and design locker rooms to the minimum size and function for planned activity compliance. Validate space needs and accommodate for music, early childhood program and Husky Den, offices, and storage. Seal and caulk all of the wall and ceiling penetrations. Replace the ceilings, remove wall tiles, paint walls, add acoustical panels, finish floors, replace lighting and controls, upgrade plumbing fixtures, replace ventilation system, and recommission all HVAC controls in all areas.

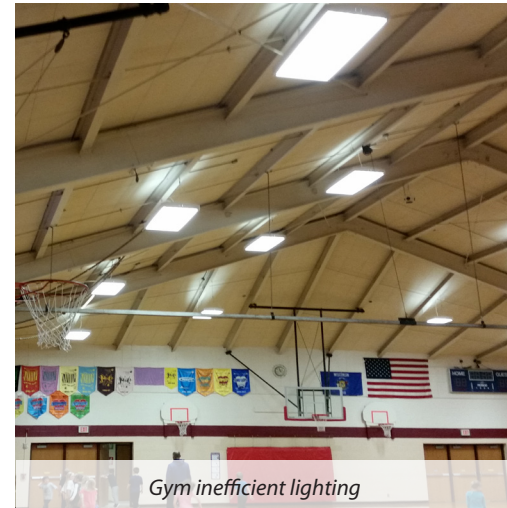
*Gym inefficient lighting*

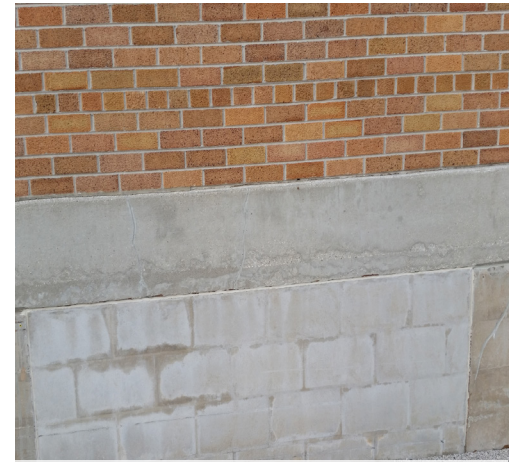
*Past visible wall patches*

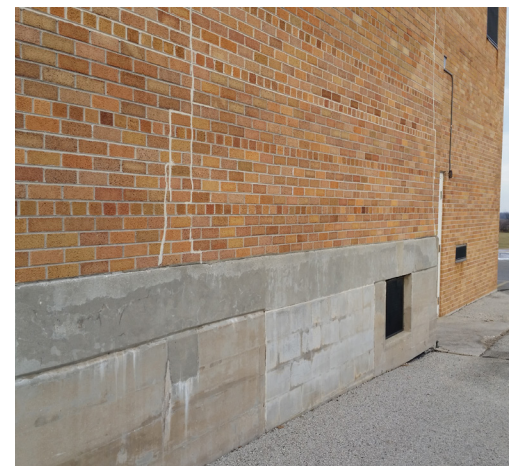
*Past visible wall patches*

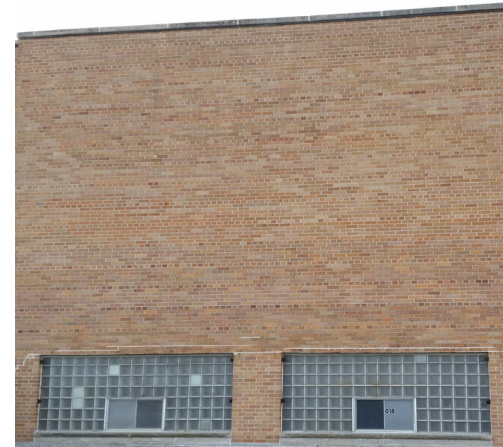
Glass Block Windows

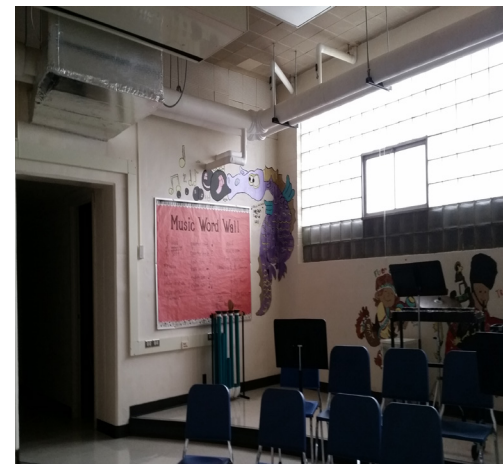
Interior View of Glass Block Windows

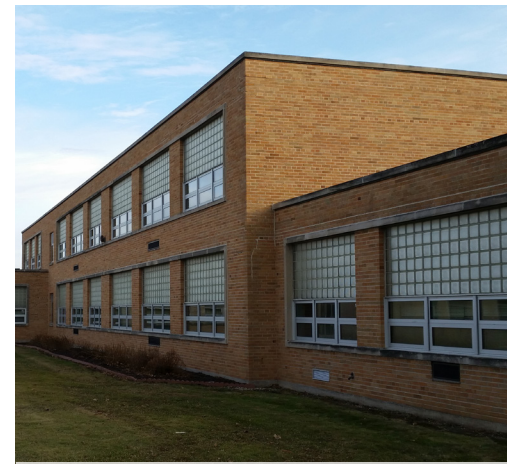
Combination glass and metal windows

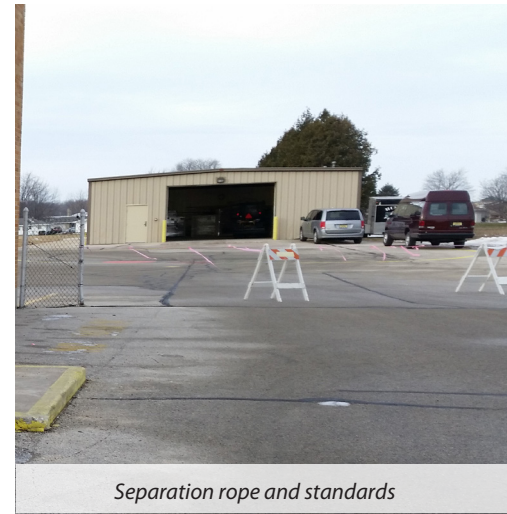
The final hardscape concern is use of a temporary separation barrier rope to separate the bus lot and other vehicle lots during bus loading and drop off. The light weight rope and standards do not provide the more rigid and durable separation recommended used for this purpose.

*Separation rope and standards*

Replace lot separation rope and standards with a more permanent and secure roller gate and fencing to isolate traffic types during bus loading/drop off periods and other events.

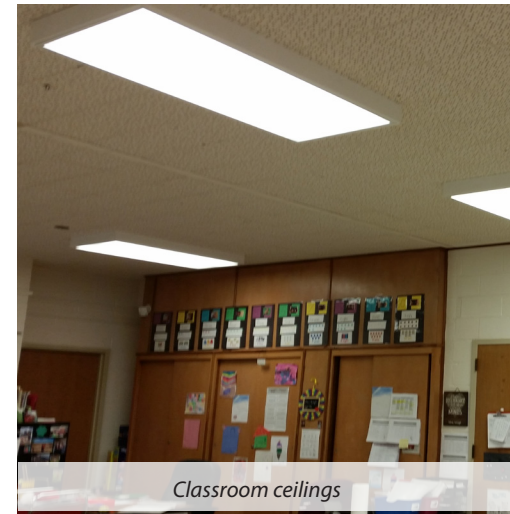
The ceiling is deteriorating and with the exposed heating piping provides an unfinished appearance. The lighting and lighting controls are outdated and inefficient. Unit ventilators are outdated and have program controls that are no longer supported. An unstable subfloor with loose surface tile exists in 1956 wing (current art area). Most of the cabinetry is outdated and in poor condition.

The greatest concern for classrooms are the ceilings and unfinished appearance. The exposed heating piping; abrupt transitions between doors, window, and fixtures; and discolored and deteriorating ceiling tiles create a unattractive environment. The large and differing windows types mentioned earlier in this report also add to the unattractive appearance of the classrooms.

Lower ceiling and replace ceiling tile to improve appearance, enclose some of the heating piping, and increase ventilation in the occupied space. Create smooth transitions between ceiling elevations and other surfaces such as doorways to further improve appearance.

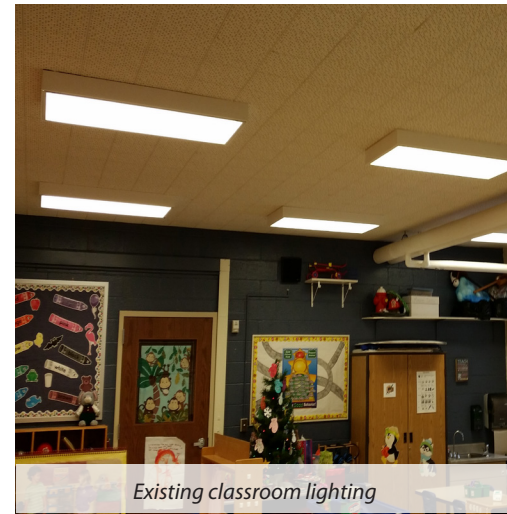
The second greatest concern in the classroom are the outdated controls for the unit ventilator heating units and lighting. The unit ventilator schedule and set point program controls are no longer supported by the manufacturer and are due for upgrade and replacement. The lighting and controls are also not energy efficient and due for replacement and upgrade.

Replace lighting and lighting controls as part of the ceiling replacement. Reconfigure lighting fixture layout to reduce the number of fixtures. Replace and upgrade unit ventilator controls for maintenance and operations savings. Coordinate lighting and HVAC controls with occupancy sensors for energy savings.

- Install LED lighting and controls.
  - Replace unit ventilator control boards and upgrade unit ventilator controls.
  - Coordinate occupancy sensors for lighting and HVAC systems.
-

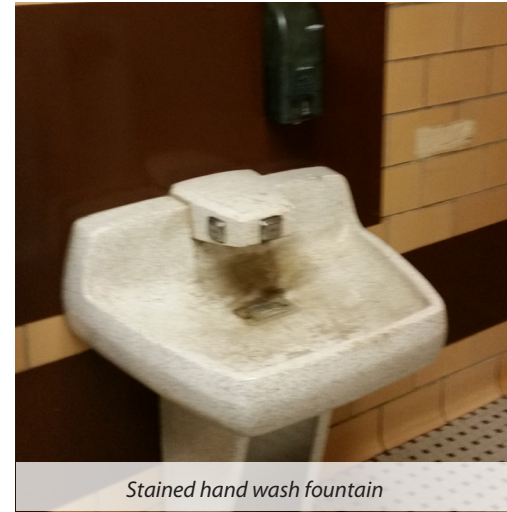
The final concern in the condition of the fixtures. Some fixtures are permanently stained with original finishes discolored, worn away, and corroded.

Update and replace plumbing and wall fixtures to improve sanitation and maintenance & operations. Resurface floors and walls with standard finishes to improve appearance, sanitation, and maintenance. Replace stall partitions and paint all paintable surfaces to improve appearance.

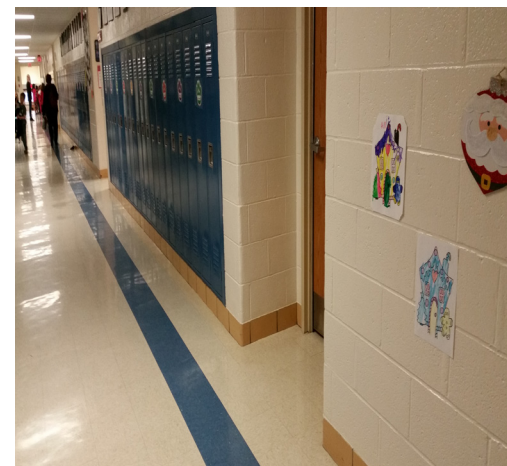
Ceramic tile base in corridors

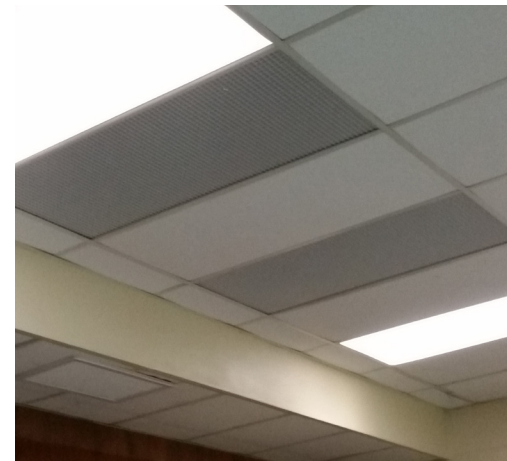
Classroom ceiling

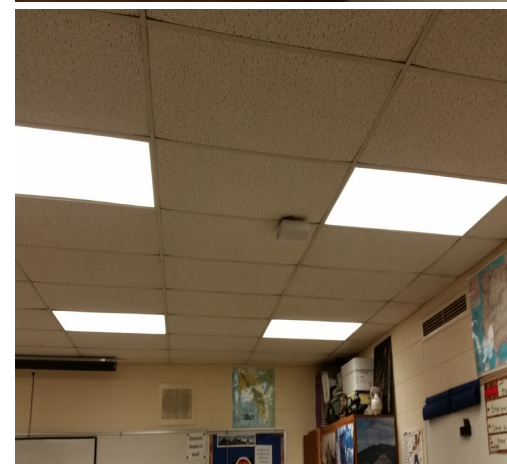
Classroom lighting

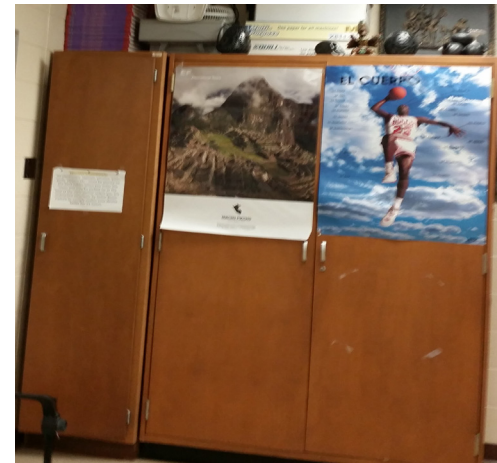
*Classroom cabinets*

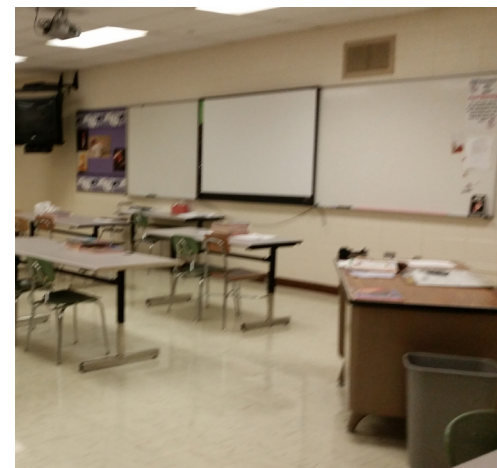
*Classroom teacher's desk*

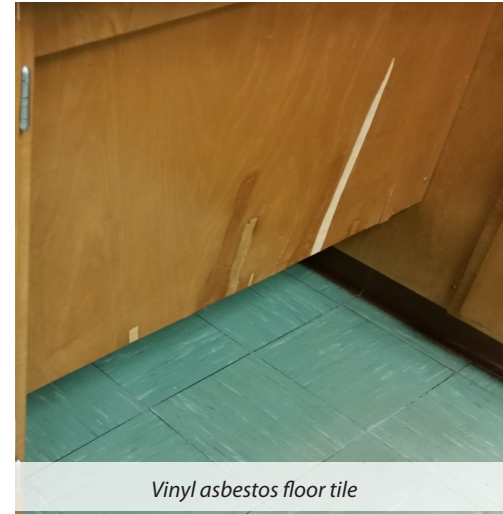
Vinyl asbestos tile (VAT) is on the floors in most of the high school lab rooms (Science, biology, consumer education, and art). Lighting and lighting controls are outdated and inefficient. Ceiling tiles and suspension grids are stained and discolored. Lab plumbing fixtures, sinks, work tables, cabinets, and teacher desks are outdated and in poor condition. Metal door frames are worn and scratched.

The greatest concern for lab rooms is the vinyl asbestos floor tile in most lab rooms. The tile contains the hazardous material asbestos and is a safety concern. The VAT also requires additional management and building services to maintain. The tile is discolored and stained in many lab room areas.

Properly abate and remove the hazardous asbestos materials from the lab classrooms. Re-tile the floors with vinyl composition tile (VCT) matching other VCT in the building.

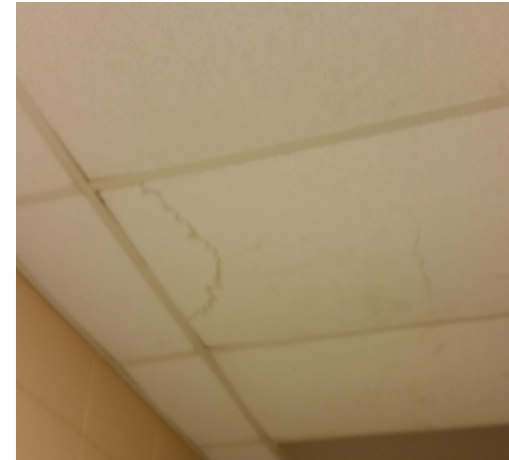
Ceiling tile and discolored suspension grid

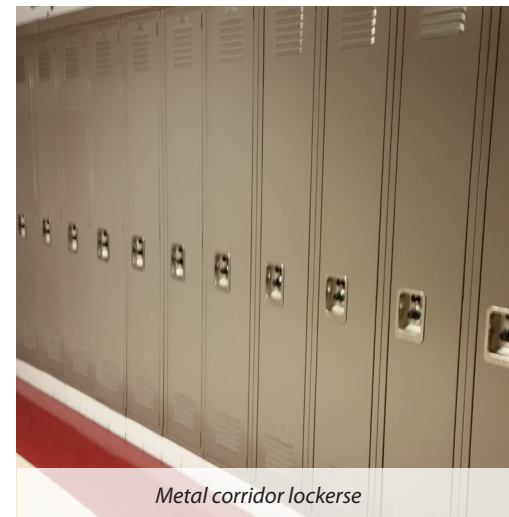
Metal corridor lockers

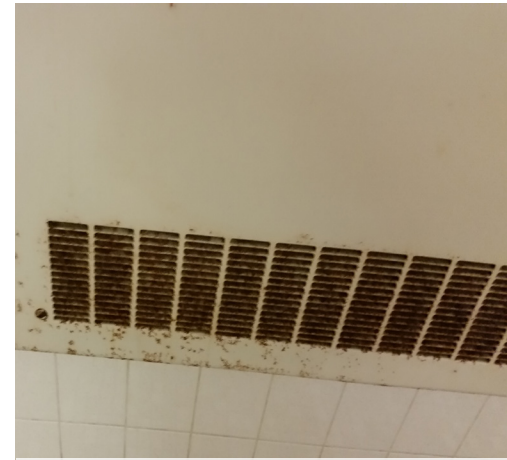
High school wall cabinet heater

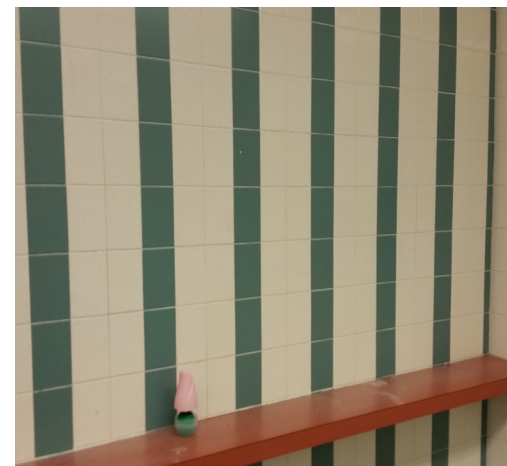
The greatest concern in the restrooms are wall tiles, floor tiles and fixtures are stained and out of date. The restroom stall partition colors and materials clash with the other finishes in the rooms.

High school wall tiles

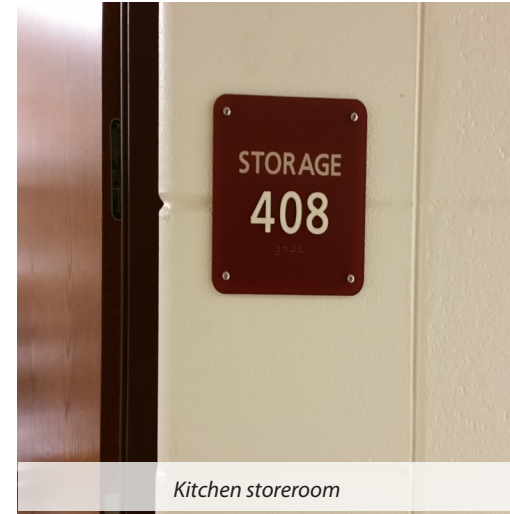
The greatest concern for building operations is the reoccurring water infiltration into the kitchen storeroom located near the center of the building. The leak appears during heavy rain storms. The staff is prepared to contain the leaks during rain events and clean up after. The concerns are not knowing the source, the other potential damage being created under the building, and the need to monitor, contain, and clean up after each leak.

A basic leak investigation study on reoccurring leaks into the kitchen storeroom should be completed. The cost to contain and properly drain the excess water during rain storms can be estimated as part of the study and corrective action taken based on the investigation report.

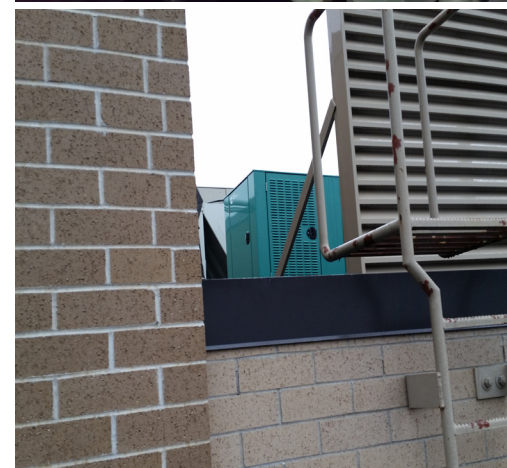
*Newer middle school generator*

Add the food service circuit and high school emergency circuits to the middle school generator. Decommission the high school generator once this has been accomplished.

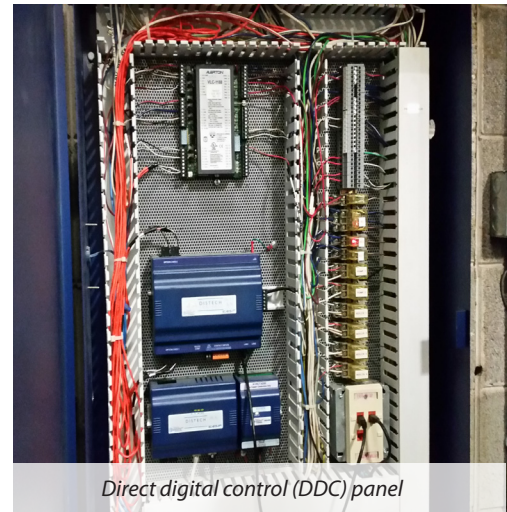
The next building operations concern is the condition the chilled water pumps and lack of recommissioning the other building systems, equipment, and controls. The chilled water distribution system includes inefficient pumps and constant volume chilled water delivery to the terminal HVAC units. The existing pump motors lose energy in the form of heat, friction, and other motor (core) losses. The current pumping system is delivering a constant amount of water throughout the building at a constant water supply temperature. The overdue recommissioning of other pieces of equipment, systems, and controls increases the potential for other inefficient building operations such as the chilled water pumping.

*Direct digital control (DDC) panel*

Replace the chilled water pumps and motors with NEMA premium efficiency motors. Install variable speed drives on the pump motors to reduce the energy used by slowing down the motor when the demand for chilled water flow is less than the maximum amount. Recommission the other building operations equipment, systems, and controls to schedule, sequence, and operate within the most efficient set points for building operations during varying conditions. At a minimum control strategies such as morning warm-up, maintaining night set-back temperatures and classroom temperature monitoring will be verified or restored with the recommissioning.

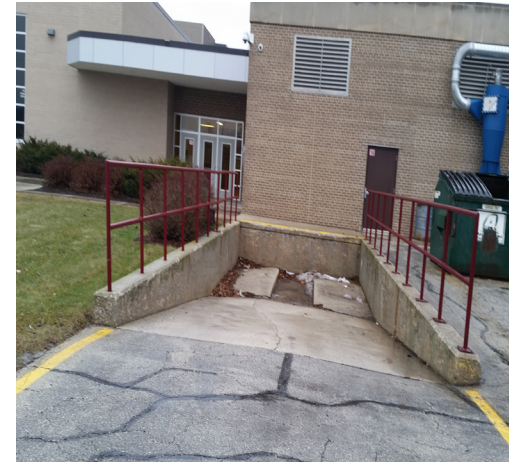
The greatest concern for hardscapes is the access to and condition of the dock and receiving area. Due to the current marked traffic pattern and parking areas the access to the dock is restricted. The dock base, walls, and receiving deck need concrete repairs and additional safety railings for operator and site occupant protection.

Receiving dock entrance drive

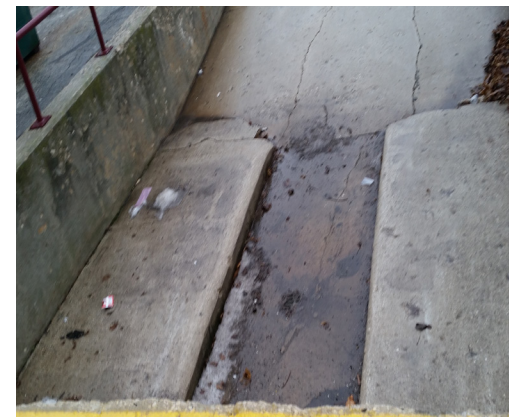
Receiving dock drive base

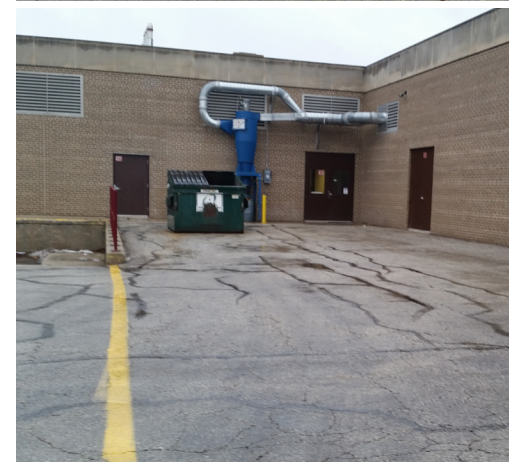
Receiving dock top deck

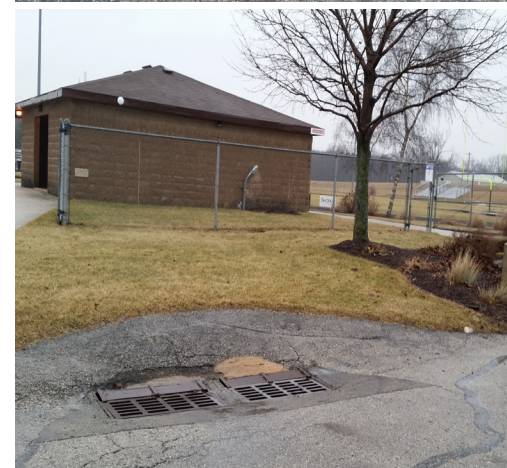
The second greatest concern is the condition of the west lot asphalt. Pot holes, large cracks, and gaps have formed on the asphalt surface. The drainage from the lot is spilling over the west edge and draining to the athletic field areas.

West lot drainage basin

Excavate the west lot base for proper drainage, replace asphalt, and restripe and paint. Excavate the east lot and visitors' lot base for proper drainage, replace asphalt, and re-stripe and paint. Most of this work is planned for completion over the summer in 2019.

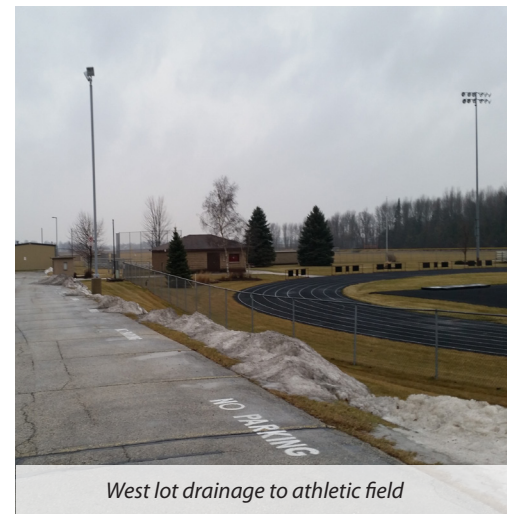
West lot drainage to athletic field

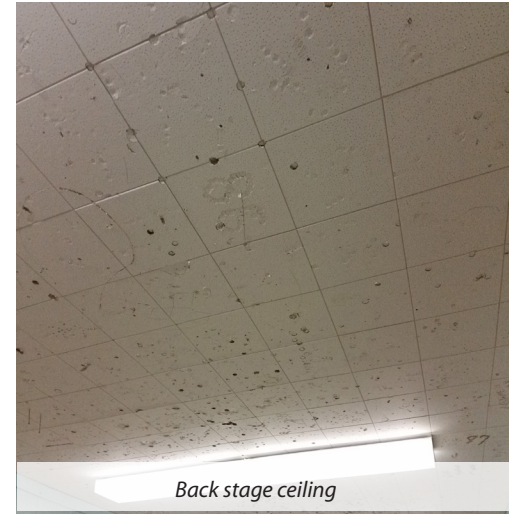
The greatest concern for the auditorium area is the damaged and hazardous material containing interior finishes. The ceiling is damaged and needs to be replaced. The floor tile contains the asbestos and is a safety concern. The VAT also requires additional management and building services to maintain. The tile is also discolored and stained.

Properly abate and remove the hazardous asbestos materials from the floor areas. Re-tile the floors with vinyl composition tile (VCT) matching other VCT in the building. To improve appearance and ongoing maintenance replace ceiling tiles with suspension grid/tile ceiling.

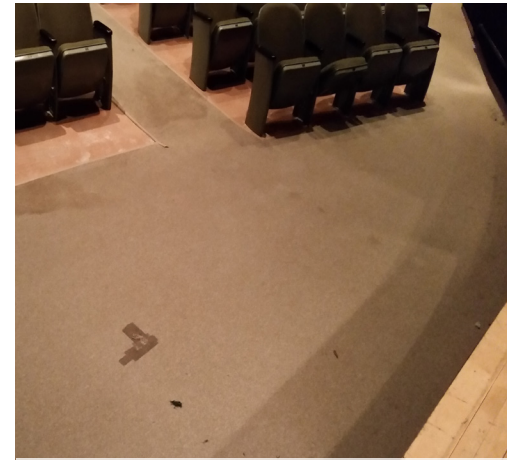
The second greatest concern is the interior finishes in the very large auditorium room. The room conditions are unattractive and uncomfortable for occupants. The carpeted areas are stained and torn. The seating has worn upholstery and uncomfortable seats. The walls and ceiling are dingy.

Auditorium carpet

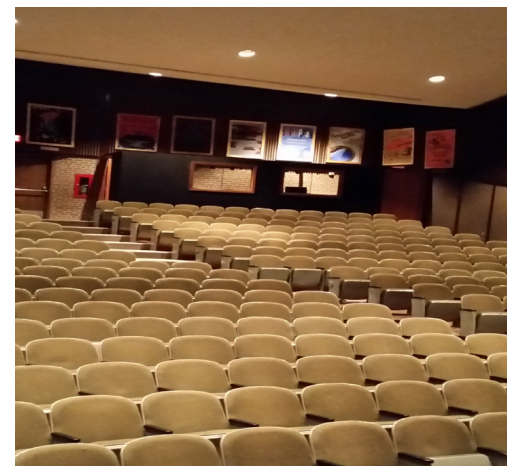
Auditorium seating

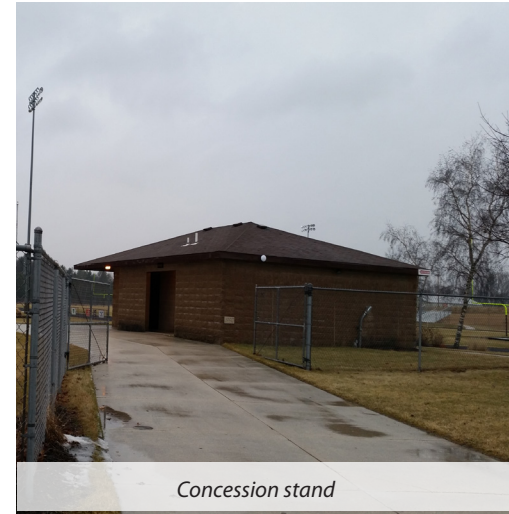
The limestone dimensional edge and face stone used to trim the building had become soiled, stained, and has minor cracks in the mortar joints. The stone face has accumulated air borne dirt, soot, and mild acid staining due to the environmental conditions. This is most noticeable when the surface is wet.

Concession stand

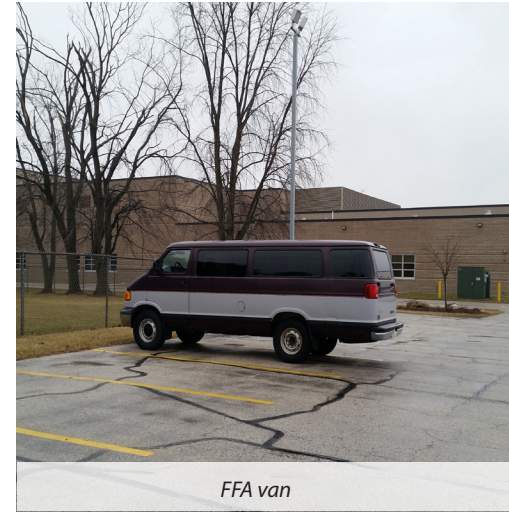
FFA van
